1942 Vintage API-ASME Vessel Revitalization

**Intersection of FEA, PCC-2,
and NBIC**

May 2015 CBIA Conference

Jim Riley and Matt Andrews

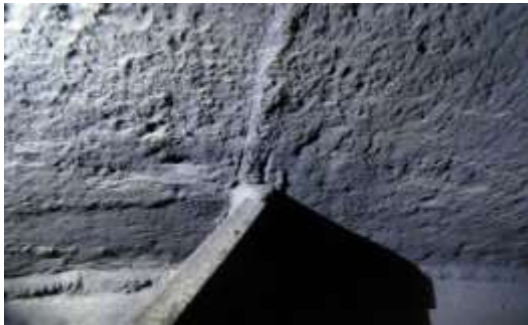
Internal Corrosion in Downcomer Area

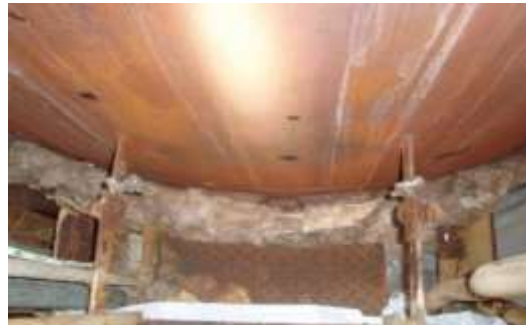
- Staging allowed access to the external shell, skirt, foundation, attachments, nozzles, etc... for visual inspection and thickness gauging. O-U API 510/NB inspector
- Located original nameplate where API-ASME code said it should be hidden under insulation below lower manway.
- Ladder, platform, reboiler support clips inspected. Some required replacement.

Lower Shell and Ladder Support Clips

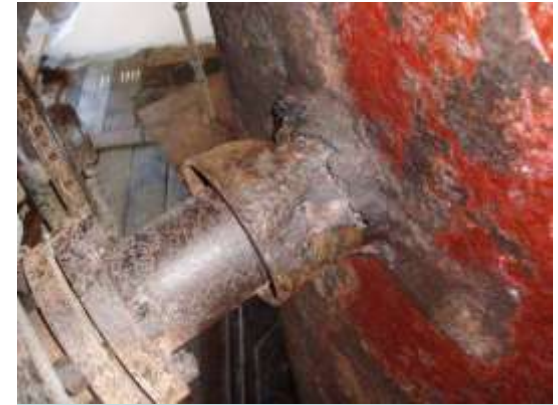
- Manual UT used to confirm lowest reading locations and mark them on the shell. Identified 4 weld repair areas, ~14 sq. ft of surface
- O-U inspector used an NDE crew to UT-grid the skirt corrosion which was similar to a 'moon crater' surface.

- The lowest thickness found was used for the skirt FEA. The foundation, anchor chairs and anchor bolts were in good condition.

Skirt Corrosion Under Fireproofing (CUF)

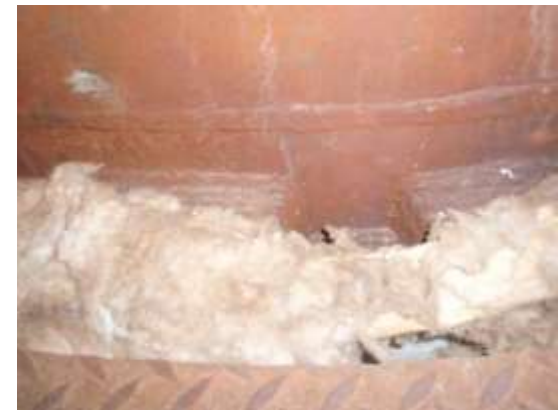
Skirt-to-head Attachment (1"-thick castellated design)

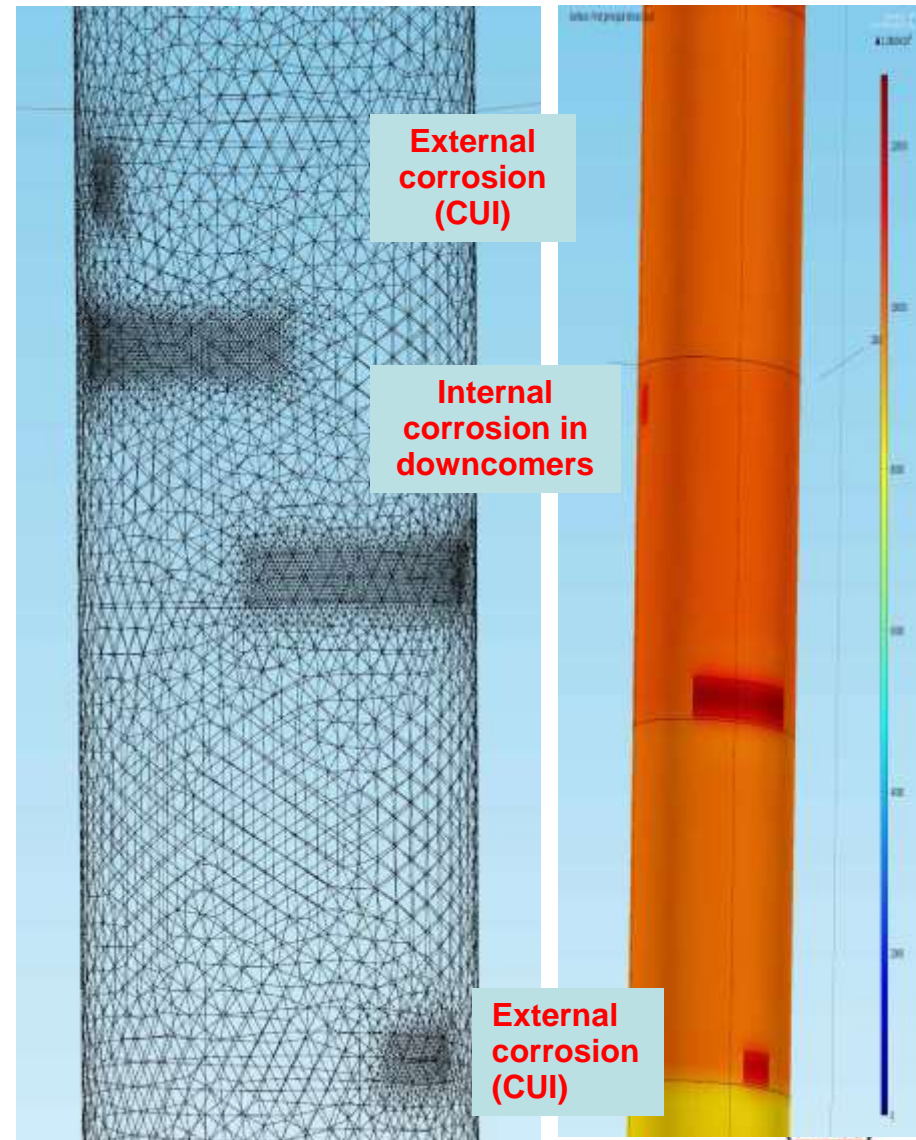
- The model was subjected to the applicable loads and the resulting stress was determined.
 - The first principle stress was on the order of the design allowable stress for the thinnest sections of the vessel at the re-rate pressure.

- The thinner sections were identified to be weld-repaired and brought to a higher thickness based on restoring to nominal thickness to satisfy future corrosion allowance.

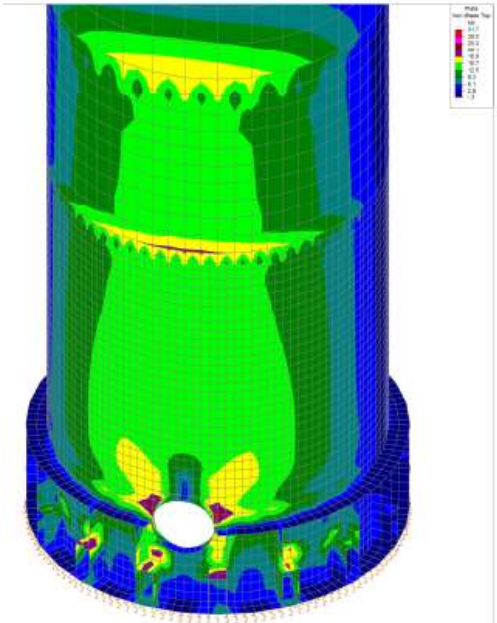
**Stiffener
ring and
manhole
repad**

- ROBERTS Engineering completed the skirt FEA using the lowest thickness from UT-grids
- A 3D model of the entire stack, skirt, each anchor chair and skirt manways was created to induce seismic loads as realistically as possible in RISA3D.
- The current CBC2013 seismic code requirements were used.
- The model was used first to analyze the vessel in its current condition.
- The model was subsequently used to model the proposed modifications to return areas of maximum stress to their original stress state comparable to that of a new skirt condition.
- The modifications included adding a welded circumferential stiffening ring to the skirt with welded stiffener-plate ties between the ring and the anchor chairs, and manhole repads which were also attached to the stiffening ring.

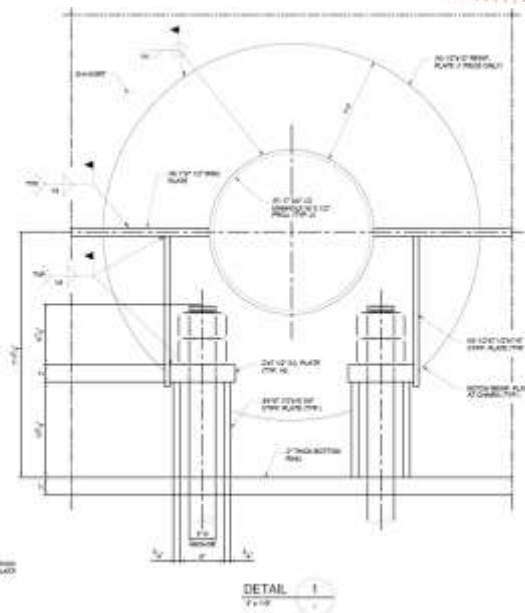
**Stiffener
plates to
anchor
chairs**

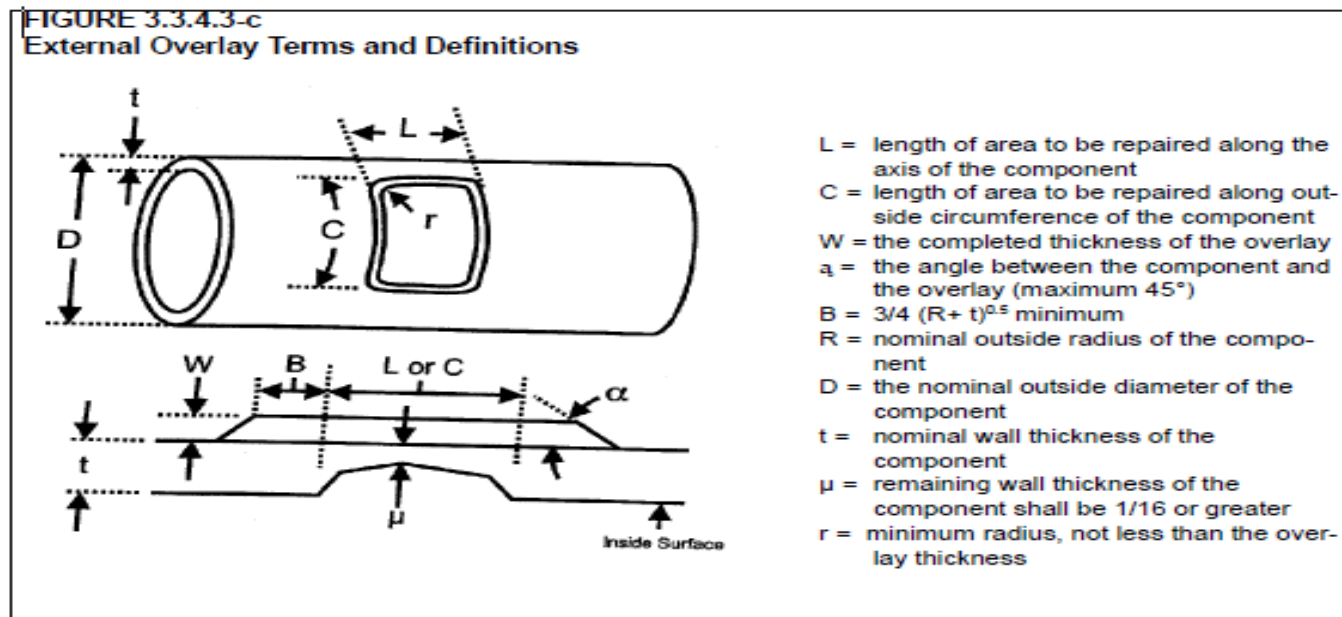
- Completed evaluation per NBIC Part 3 Section 3.3.4.3-e (items a thru m) and Figure 3.3.4.3-c (below)
- Brinderson, R-symbol stamp organization, completed code Repair Plan with weld procedure, and proposed NDE methods prior to welding and after welding completion with request to use NDE in-lieu of hydrostatic testing. Oversight by O-U AI of VT/PT/UT shearwave completed on all areas to be welded and included in request to the State.
- Leonard Tong, DOSH PV Unit, reviewed the package of information, made revisions with supplemental requirements for in-lieu of hydrotest, and approved the Repair Plan.
